Industrial Warehouse Heating Energy Case Study

Evaluation of Heating Strategies for Lanter-Gateway Commerce Center III

April 2004

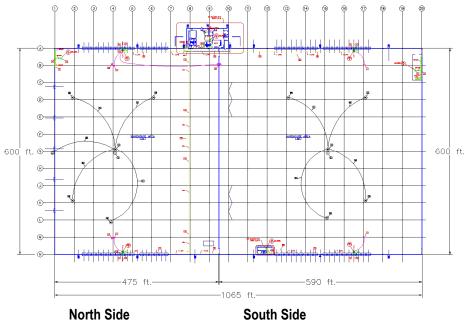
Figure 1 Lanter-Gateway Warehouse Layout

The Lanter-Gateway Commerce Center III is a 600' x 1065' (639,000 square feet) warehouse located in St. Louis, Missouri. The warehouse is divided into two sections by a permanent wall. The north side of the building is 475' x 600' (285,000 square feet) and the south side of the building is 590' x 600' (354,000 square feet). The average ceiling height of the warehouse is 40 feet.

Re-Circulating Heaters

100% Outdoor Air Heaters

Indoor and outdoor temperature is also recorded for this case study. All temperature readings are measured with two Fluke Hydra Series 2625A data loggers. J-Type thermocouples are wired throughout the building and temperatures are taken every 2 hours at every thermocouple. There is one data logger on each side of the building. The outdoor air temperature is measured in one spot and the indoor air temperature is monitored in 16 different spots. The temperature is measured at 8 spots on each side of the building. The 8 spots consist of 4 ceiling level readings and 4 readings just above floor level. The thermocouple building grid positions are indicated in the table below and the grid is defined in figures 1-3.

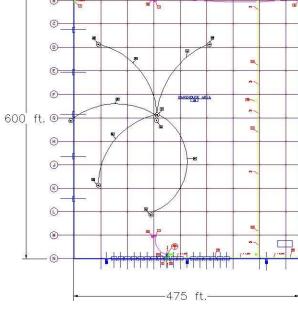
Figure 2
North Side of Building

Thermocouples Indicated by Curved Lines

Re-circulating Heaters Located above Shipping Doors

The north side of the building is heated with two 17000 CFM, 2.1 MBH recirculating direct gas fired heaters. The heaters are configured to continuously operate and the outdoor air and return air dampers are configured to operate off of a building static pressure control. The heater continually monitors space temperature and the burner modulates to maintain a constant space temperature.

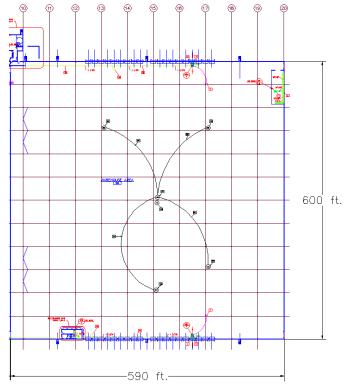
Figure 3
South Side of Building

Thermocouples Indicated by Curved Lines

100% Outdoor Air Heaters Located above Shipping Doors

The south side of the building is heated with two 17000 CFM, 2.1 MBH 100% outdoor air direct gas fired heaters. The heaters are configured to cycle on and off dependent on space temperature. The blower and burner will turn on when the space thermostat is not satisfied and will turn off when the space thermostat is satisfied.

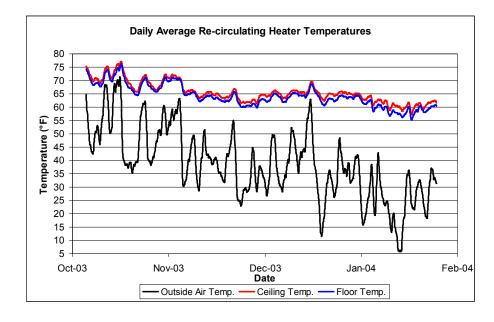
Figure 4
Daily Average North Side
of Building
Temperatures

The daily average indoor ceiling, indoor floor, and outdoor temperatures are shown in the following graphs. The first graph shows the north (recirculating) side of the building and the second graphs shows the south (100% OA) side of the building.

Re-circulating

While both heaters maintained a rather consistent average space temperature, the hot air stratification was lower on the re-circulating heater side of the

building by .27°F. This is a direct result of using the warm ceiling air as the return air source.

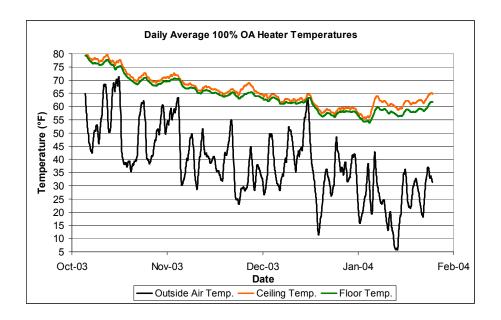
Figure 5
Daily Average South
Side of Building
Temperatures

100% Outdoor Air

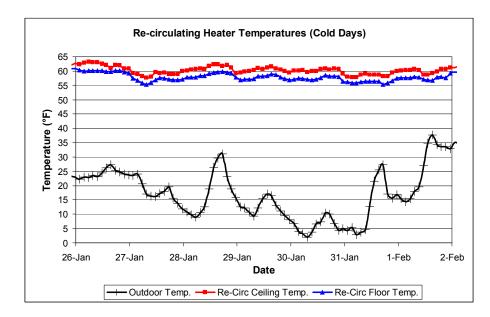
Figure 6 Coldest Days of North Side of Building Temperatures

The coldest portion of the analyzed timeframe is shown in the graphs below. The first graph shows the north (re-circulating) side of the building and the second graphs shows the south (100% OA) side of the building.

Re-circulating

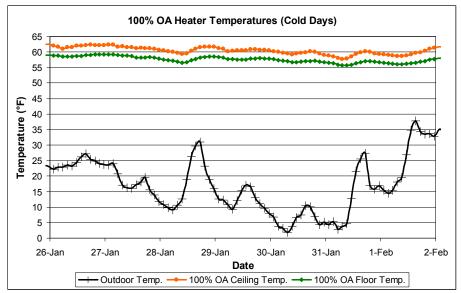
Figure 7 Coldest Days of South Side of Building Temperatures

100% Outdoor Air
